TRANSMISSION THERMAL MAPPING (CH-47C
FORWARD ROTOR TRANSMISSION)

Boeing Vertol Company

3. REPORT TITLE TRANSMISSION THERMAL MAPPING (CH-47C FORWARD ROTOR TRANSMISSION)		
4. DESCRIPTIVE NOTES (Type of report and inclusive dates) Test and Demonstration Report (Final Report)

5. AUTHOR(S) (First name, middle initial, last name) Rocco C. Tocci A. J. Lemanski Nelson J. Ayoub		
6. REPORT DATE May 1973	7a. TOTAL NO. OF PAGES 167	7b. NO. OF REFS
8a. CONTRACT OR GRANT NO. DAAJ02-72-C-0075	8a. ORIGINATOR'S REPORT NUMBER(S) USAAMRDL Technical Report 73-24

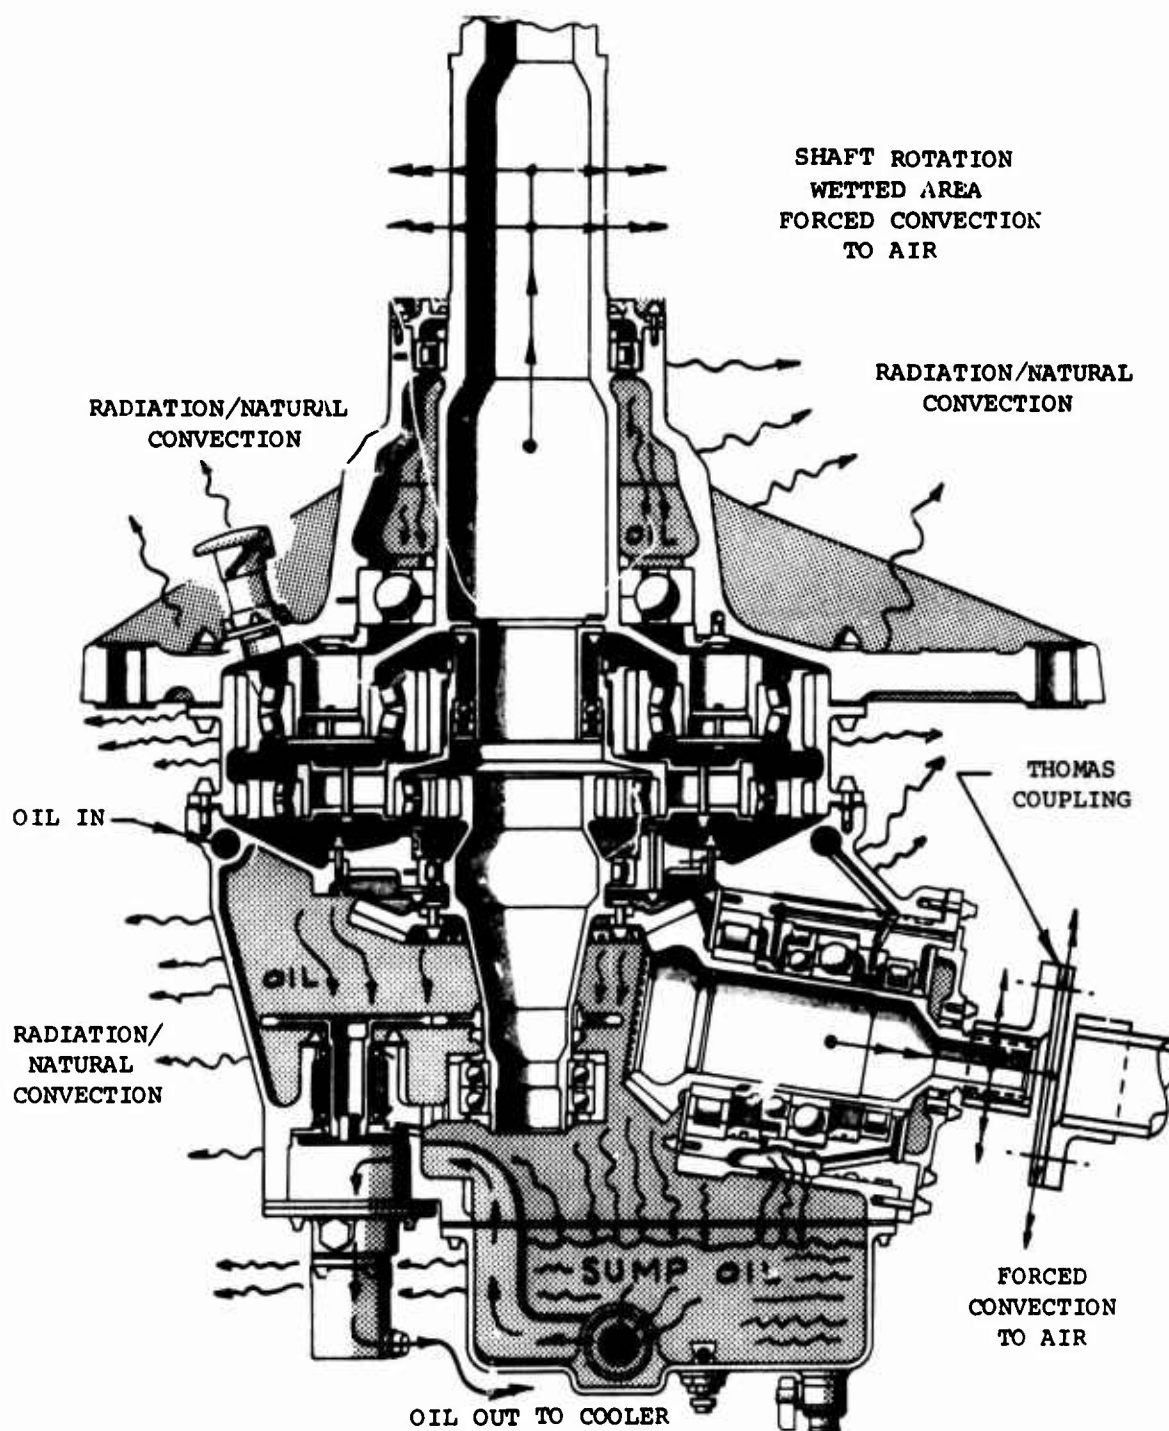
Figure 78. Illustration of Radiation/Natural Convection and Forced Convection (Oil) Heat Paths of Specimen Transmission.

Heat paths follow the dominant heat transfer mechanism(s) in any test segment. The dominant heat dissipation mechanism during tests 1, 2, and 3 is the forced convection provided by MIL-L-7808 oil. This is indicated by noting that the case temperatures are predominately between oil-in and oil-out temperatures during tests 1, 2, and 3. By contrast, the dominant heat dissipation during the hunting-search torque run (Figure 75), oil-cooler completely bypassed, is case radiation and natural convection. This is indicated by noting that the case temperatures are predominately lower than both oil-in and oil-out. In this oil-cooler bypass condition, the dominant heat transfer mechanism internally is conduction. The presence of the lubricant internally serves to modulate spikes of localized temperatures and bathe the inside of the case walls for eventual dissipation by radiation and natural

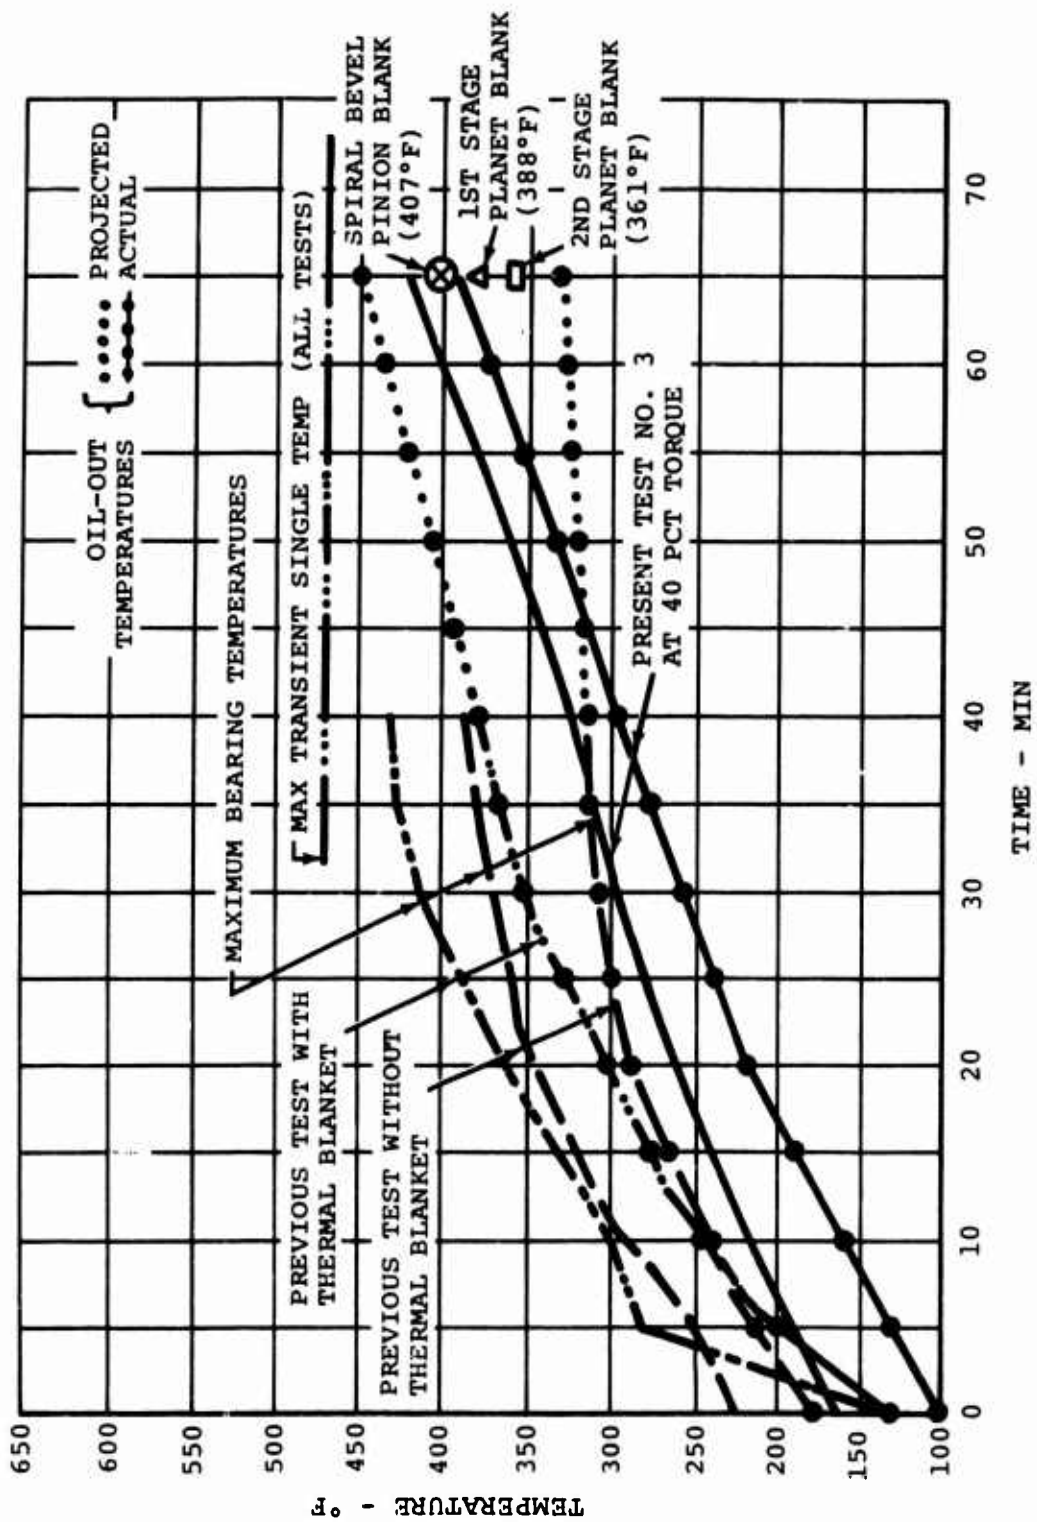
Figure 79. Comparative Temperature Histories of Prior and Present Tests.

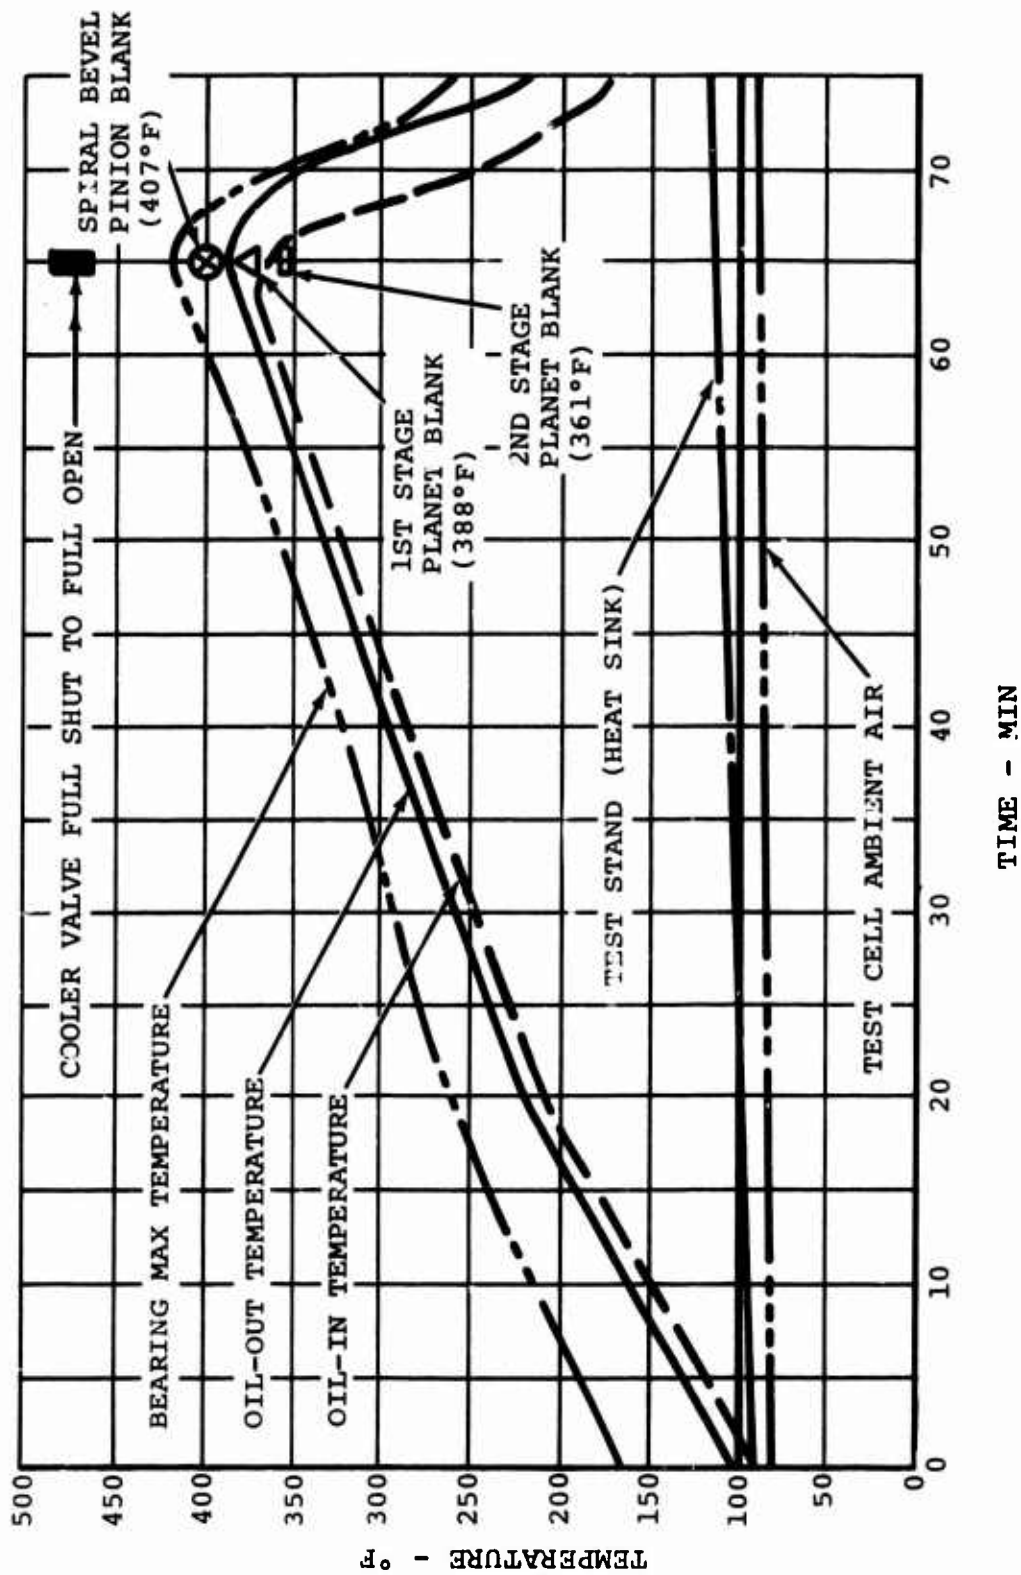
Figure 80. Temperature History of Specimen Components During Hunting/Search Torque (40 Percent) Run.

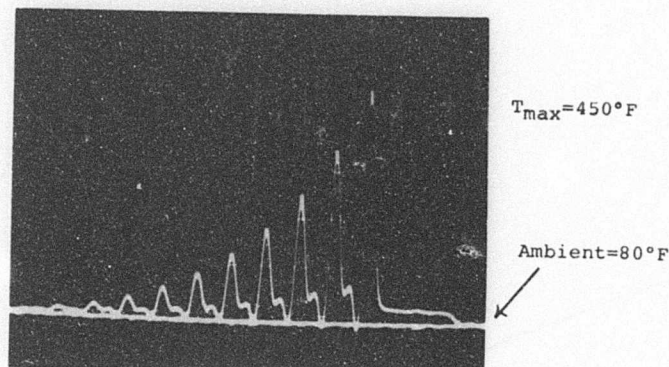
FIGURE 5
A-SCAN LINE OF CALIBRATOR

It was noted that at temperatures above 150°F the base line immediately to the left of the hot area being scanned was displaced below the initial ambient A-Scan line. This was observed for both the calibration curves, Figure 5 and also for actual test runs on an A-Scan line across the transmission housing, Figures, 16-21. This negative displacement is due to an electronic design limitation in the scanning system. The environmental ambient temperature was used for the base line

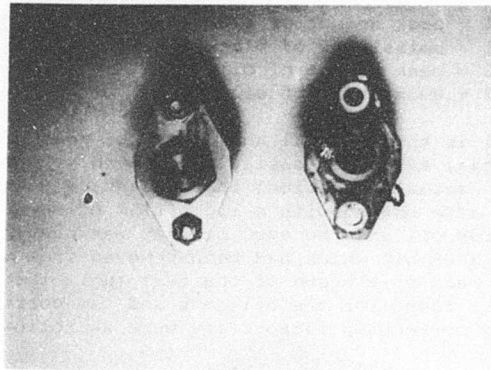
The appearance of the oil jet after the final test runs indicated that it had oxidized to a considerable extent in contrast to the shiny finish of a new jet, Figure 8.

NEW

USED

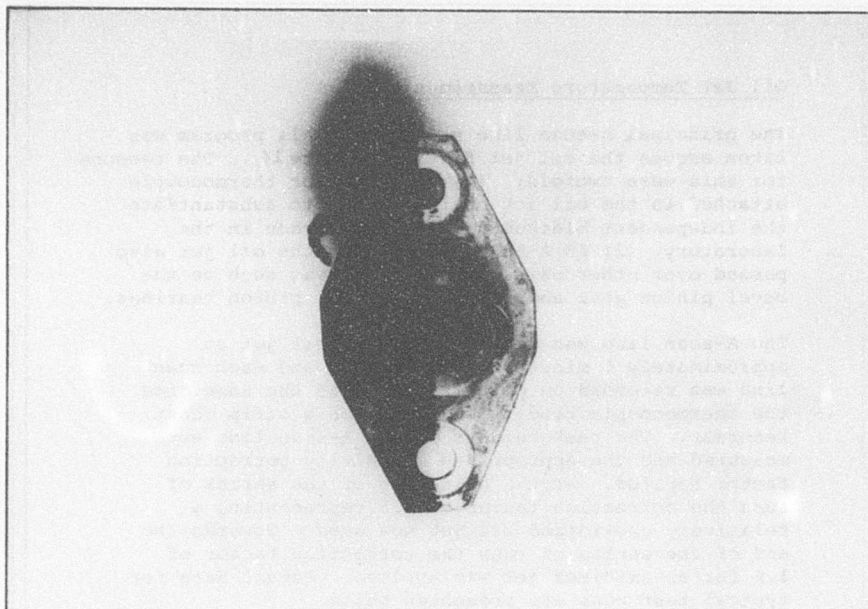
FIGURE 9
EMISSIVITY MEASUREMENT OF OIL JET

Published values of ϵ for anodized aluminum range from 0.3 to 0.77, and 0.60 for oxidized aluminum, ref. 1, 2, 3.

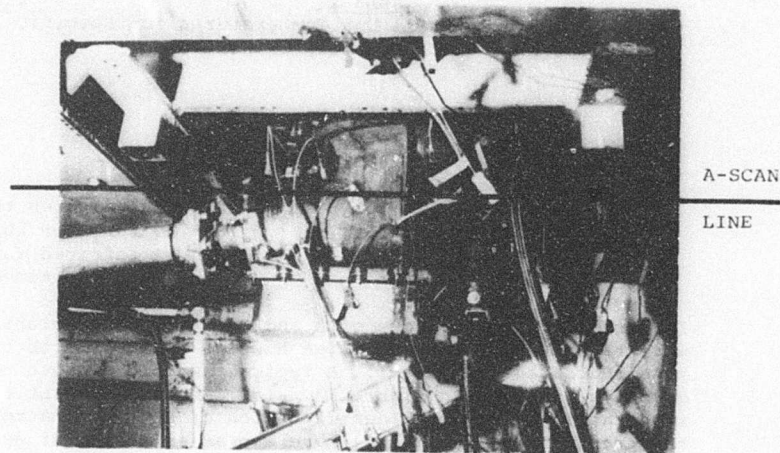
FIGURE 14
A-SCAN LINE ACROSS TRANSMISSION HOUSING

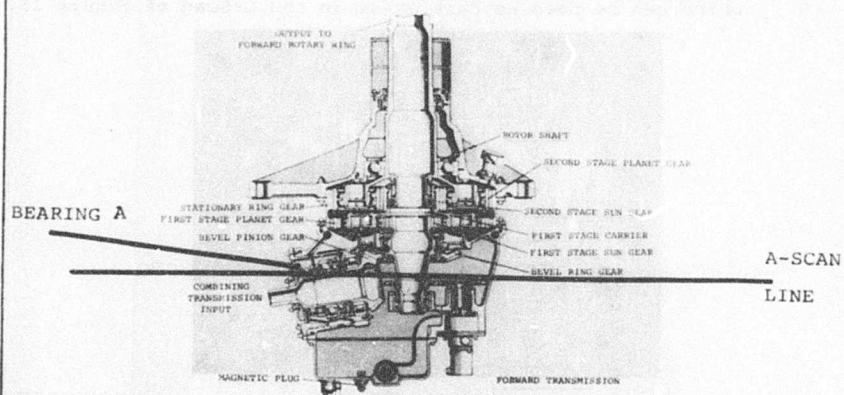
FIGURE 15
SCHEMATIC DIAGRAM OF FORWARD TRANSMISSION

Time-temperature graphs indicate that at oil-out temperatures of 175°F the temperatures of position 1 and 2 are approximately equal. Below this value the temperature of position 1 is less than that of position 2.

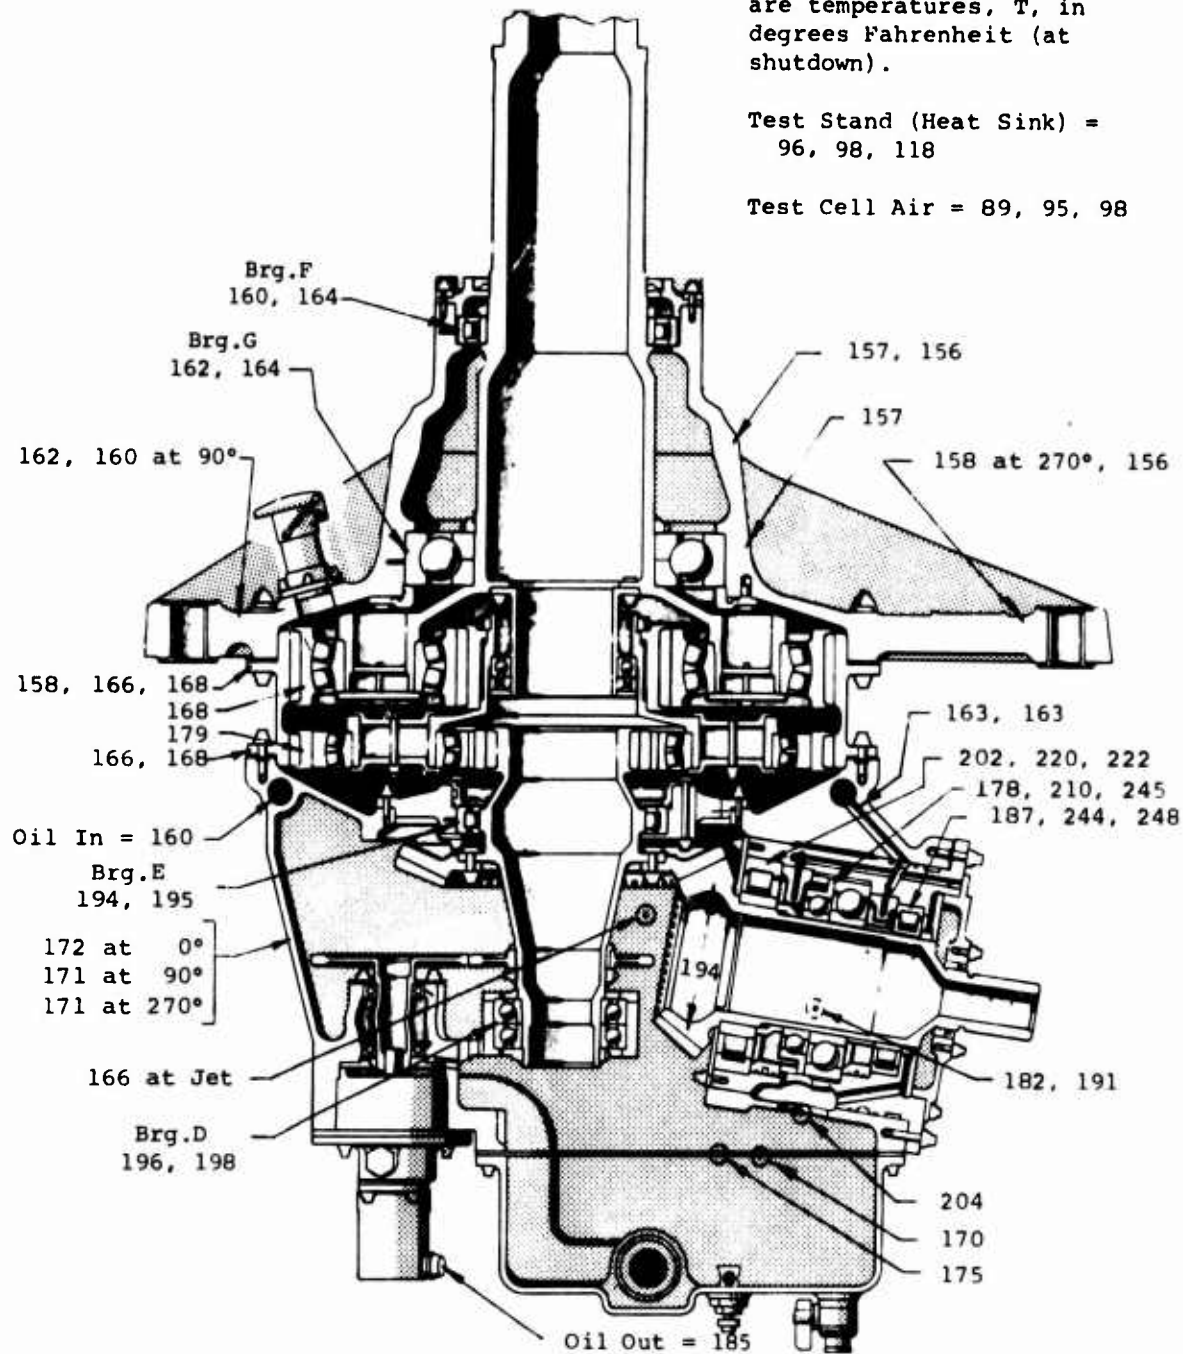
Figure 2: Thermal Record at 100% Torque - 180°F Oil-Out Temperature.

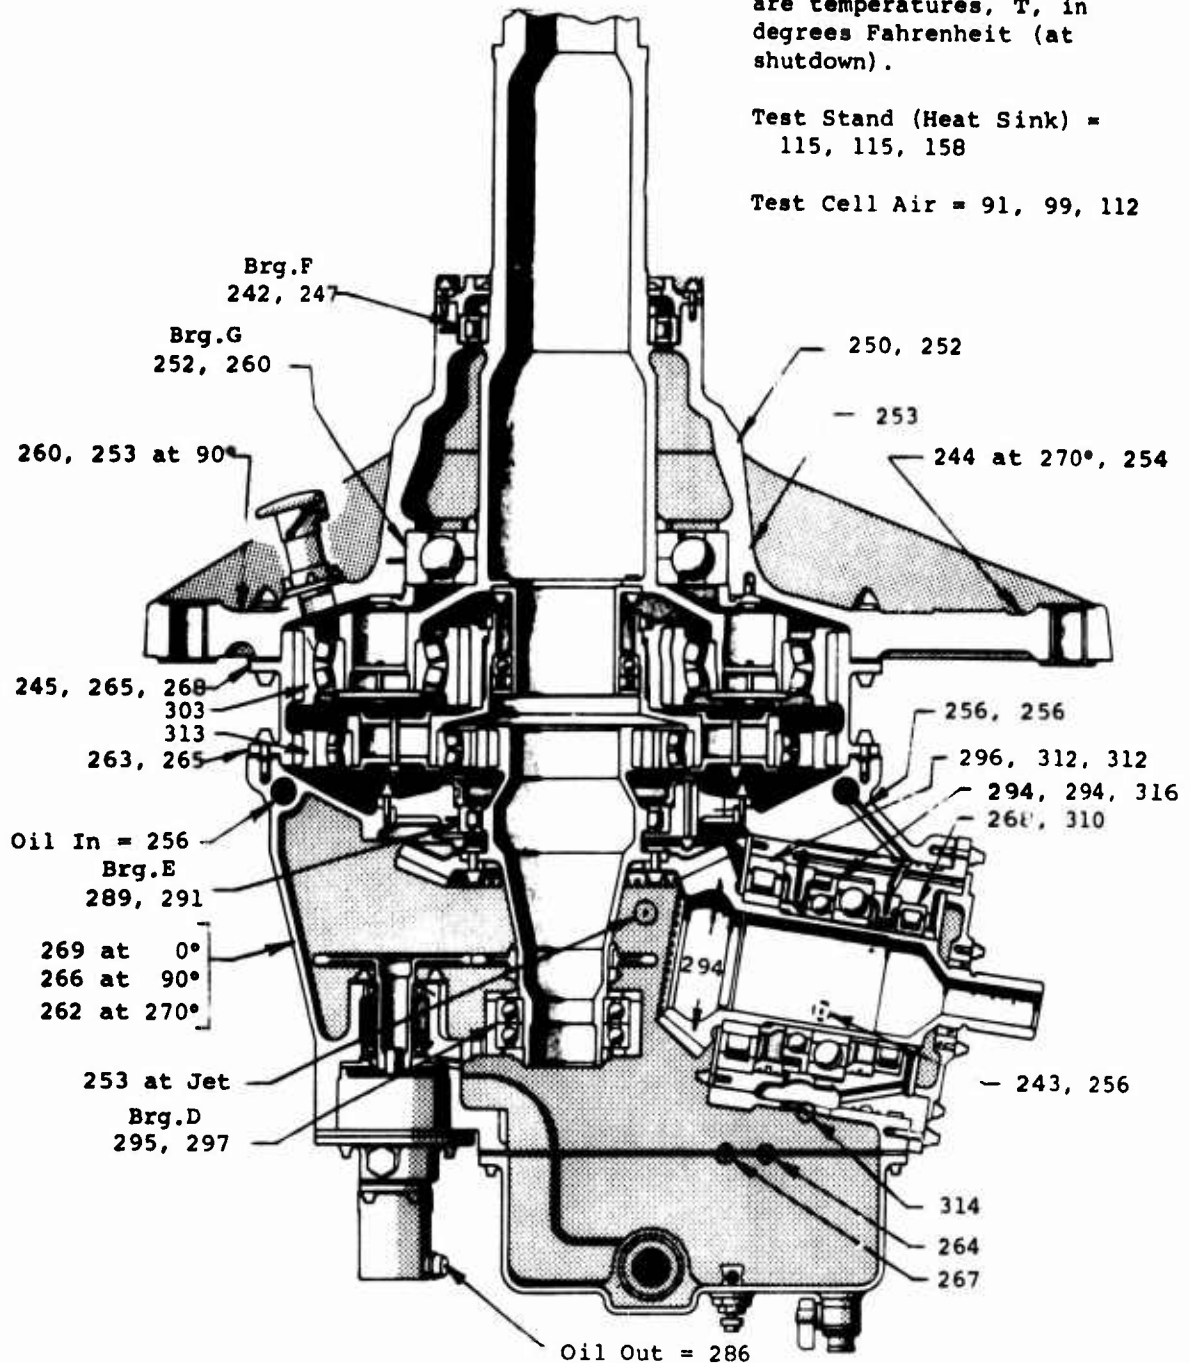
Figure 3: Thermal Record at 100% Torque - 286°F Oil-Out Temperature.

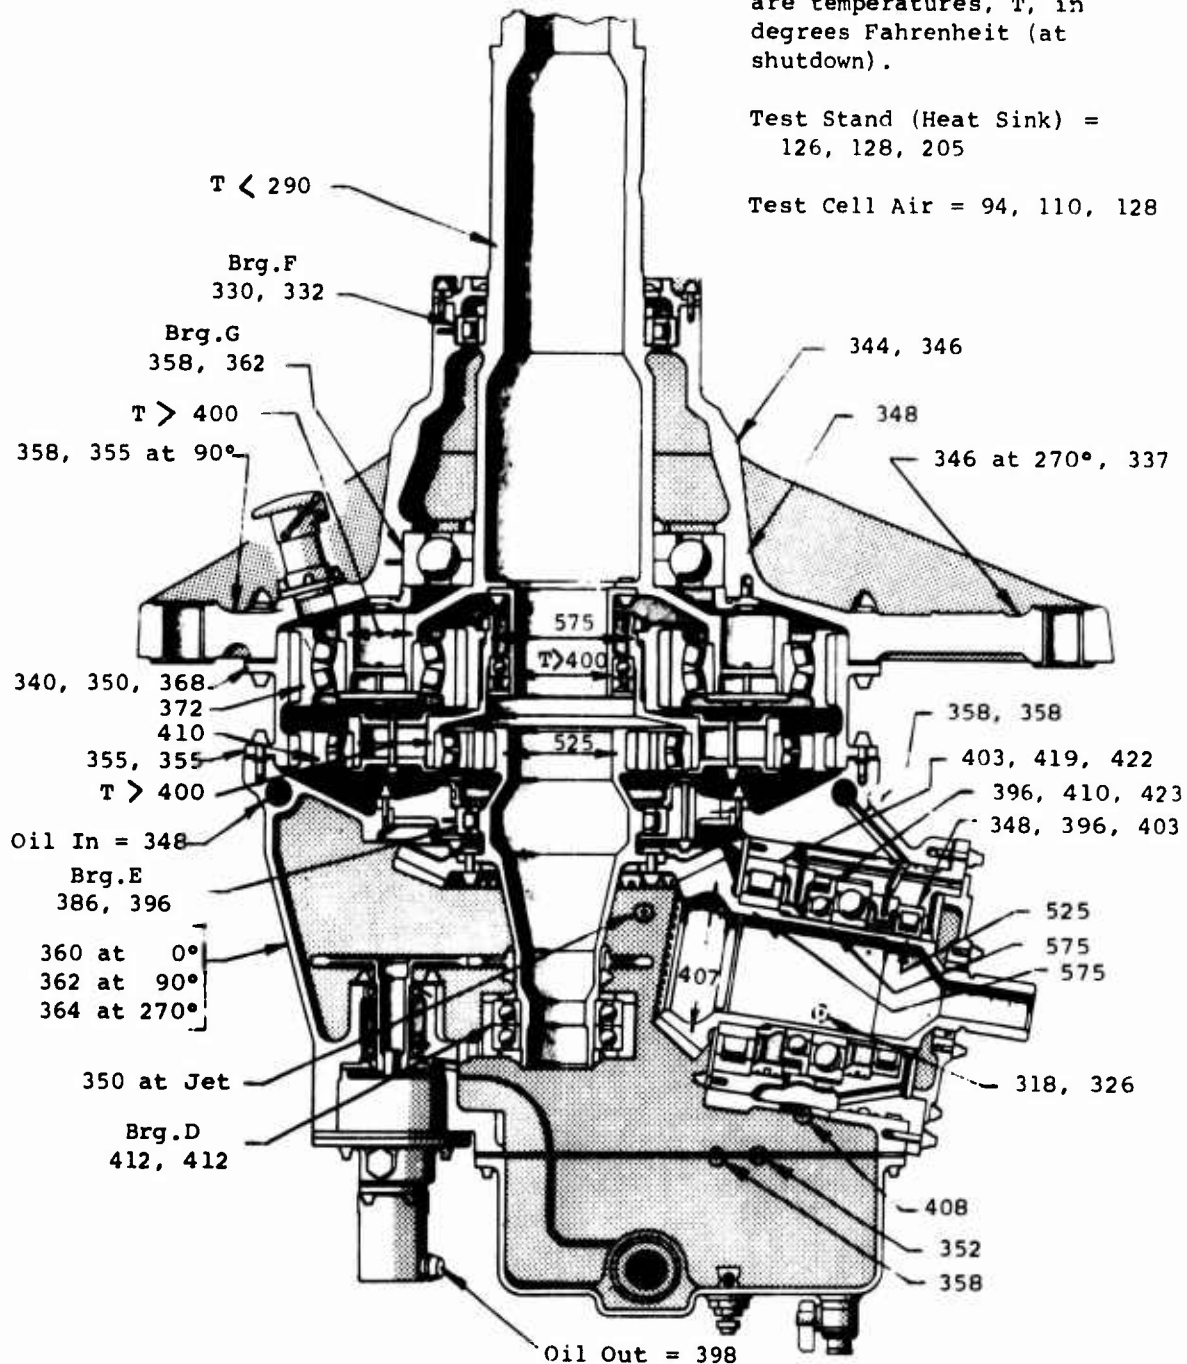
Figure 4: Thermal Record at 100% Torque - 400°F Oil-Out Temperature.

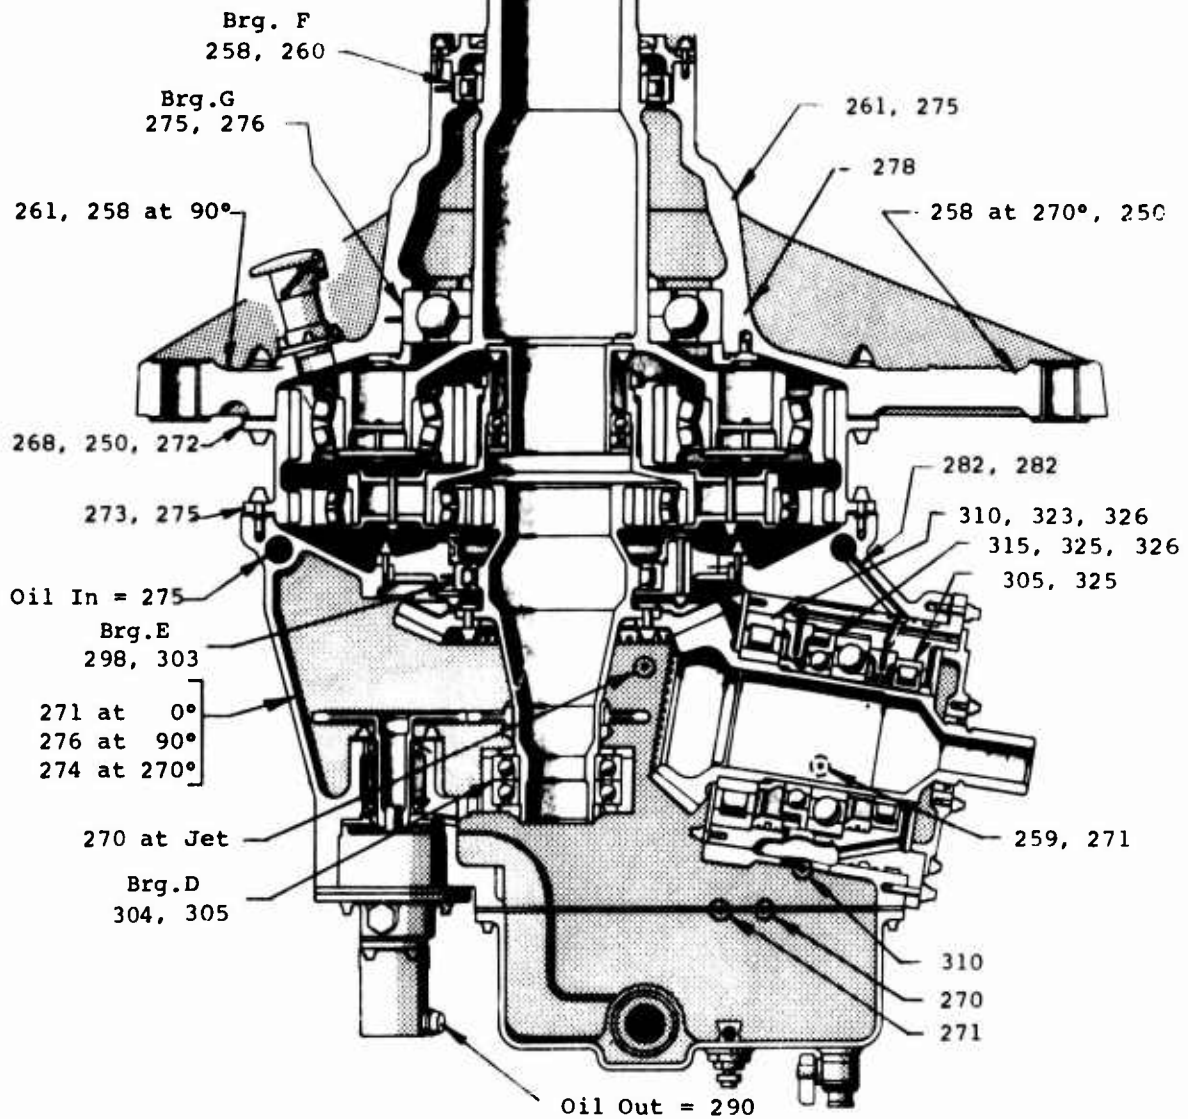
Figure 6: Thermal Record of Temperatures During Dimensional Mapping.
